MISSISSIPPI ENVIRONMENTAL GEOLOGY

David T. Dockery III and David E. Thompson

Mississippi Department of Environmental Quality
Office of Geology
Second Edition, 2019

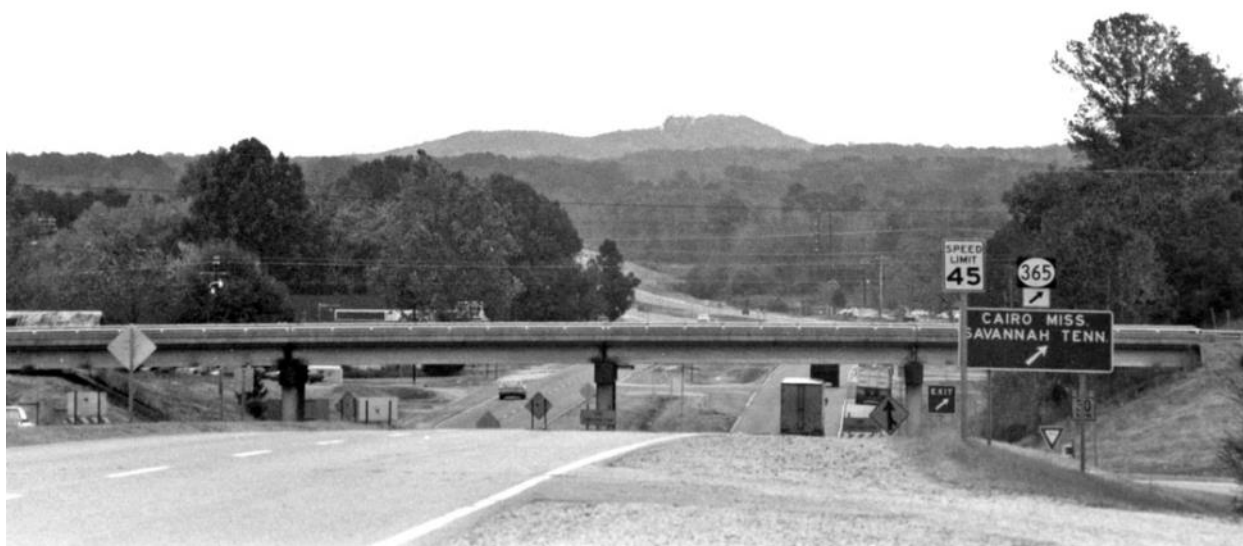
Figure 1. Woodall Mountain in Tishomingo County, Mississippi's highest elevation at 806 feet above sea level, as seen looking southeast from the intersection of Highway 72 and Highway 365 at Burnsville. Picture (scanned print; Image 1448) from Merrill (1988, p. 17).

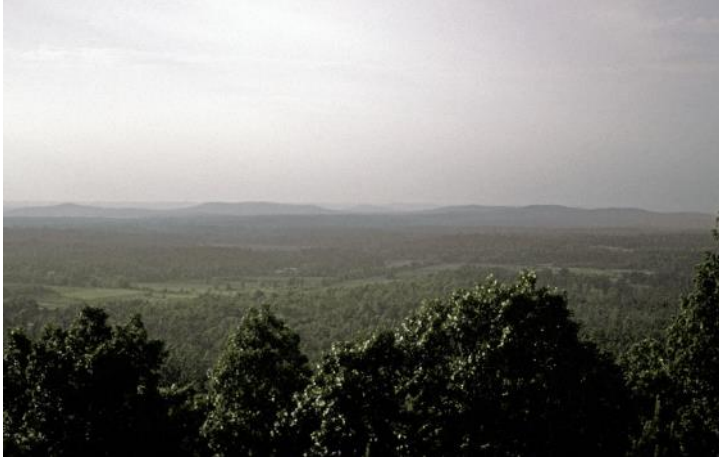
Figure 2. View from Mt. Woodall to the southwest toward Chestnut Ridge in Tishomingo County, Mississippi. High points on the ridge consist of sands in the Coffee Formation. Picture (slide 4-13; Image 1393) taken in July of 1973.

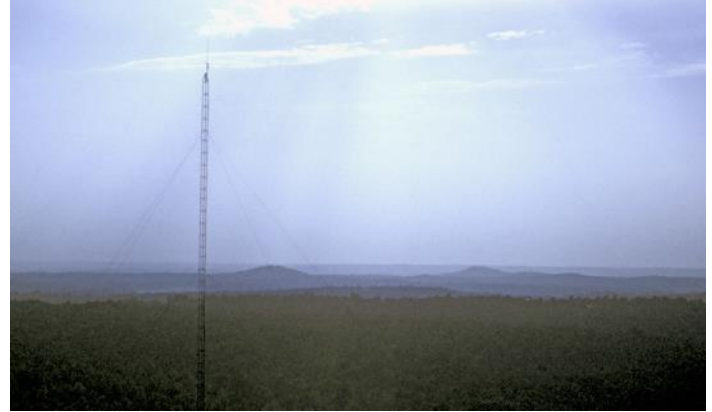
Figure 3. View from Mt. Woodall to the west. The two unnamed knobby peaks in the distance consist of sands in the Coffee Formation resting above sands in the Eutaw Formation. Picture (slide 4-14; Image 1394) taken in July of 1973.

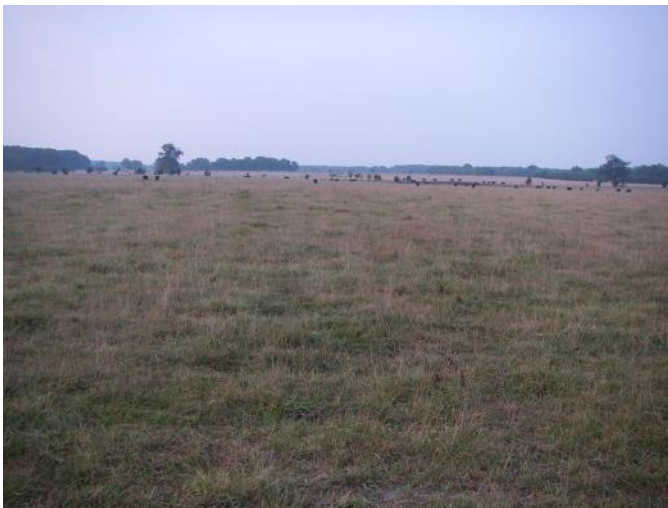
Figure 6. Cattle grazing on a rich grass field of the Black Prairie Physiographic Province near Artesia in Lowndes County. Here Black Prairie soil is developed on weathered Demopolis Chalk. Picture (digital, CD 51; Image 1054) taken on August 23, 2007.

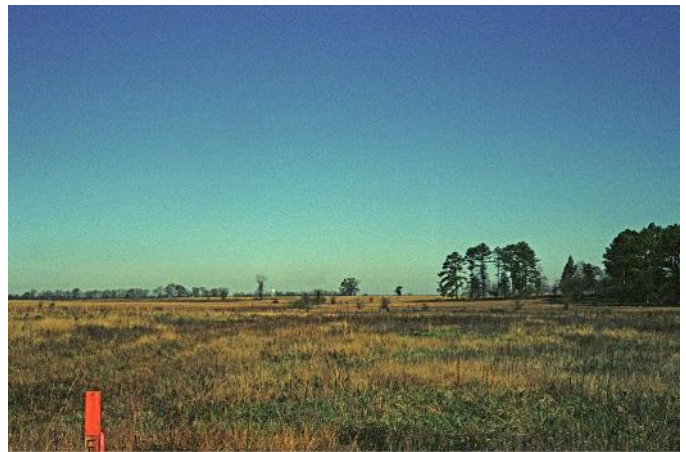
Figure 7. The Black Prairie on the Demopolis Chalk as viewed from core-hole site #2 at Brooksville, Mississippi. Picture (frame 1/0A; Image 560) taken by Ernest Russell taken in 1989.

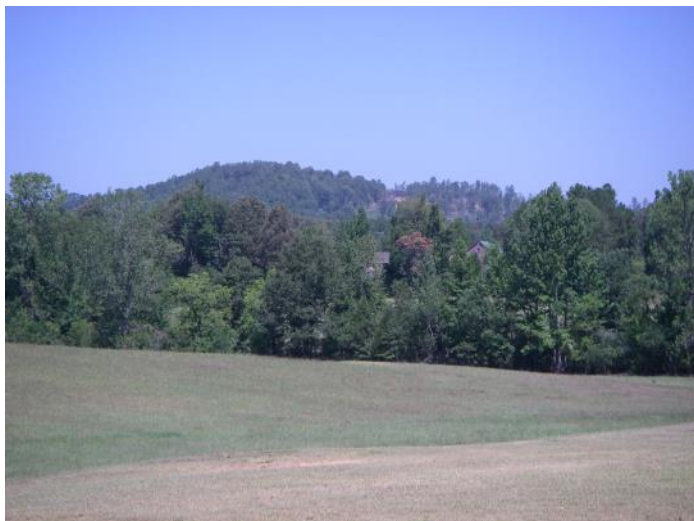
Figure 8. Lebanon Mountain in western Prentiss County, as viewed to the north from Highway 30, is 790 feet above sea level and the second highest hill in Mississippi and is capped by the McNairy Sand. Picture (digital, CD 50; Image 1044) taken on August 9, 2007.

ty Line, Lebanon Mountain rises to 790 feet in elevation, only 16 feet lower than the state's highest elevation at Woodall Mountain (**Figure 8**). A view from Lebanon Mountain was published by Blake (2006) in *Mississippi Farm Country*. Lowe (1915) noted the backbone of the Pontotoc Ridge to have an average elevation above 500 feet and to divide the waters of the Tombigbee watershed on the east and the Mississippi and Pearl River watersheds on the west. He also noted the region to be one of dense fine hardwood forests. Stephenson and Monroe (1940, p. 29-30) described the Pontotoc Ridge as resting mainly on sandy

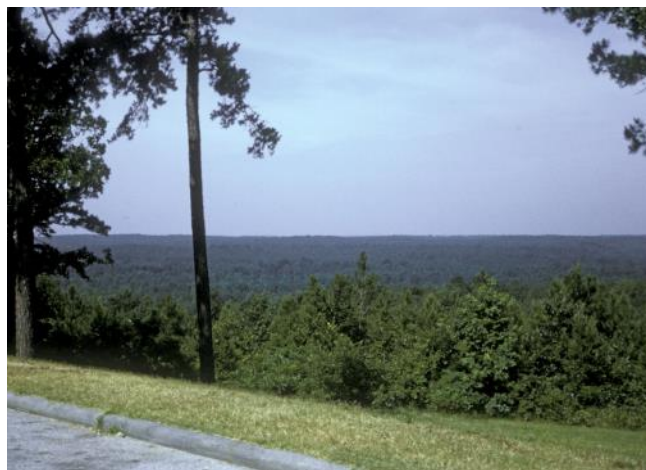
Figure 9. View to the northeast from the Wilcox cuesta on the Natchez Trace Parkway near Little Bear Mountain at Jeff Busby State Park. Picture (slide 4-6; Image 1395) taken in July of 1973.

North Central Hills Province: The North Central Hills Province overlies sandy units of the Eocene Claiborne and Eocene-Paleocene Wilcox groups. The eastern edge of this province is marked by the Wilcox cuesta escarpment (**Figure 9**), which is one of the most distinctive topographic features in northeastern Mississippi. Cuestas of the Wilcox Group and the Claiborne Group (**figures 10-14**) continue north into Tennessee and are the recharge areas for some of central and northwestern Mississippi's most important aquifers (ground water sources). These aquifers are also used extensively by the city of Memphis, Tennessee, which boasts having perhaps the nation's best public drinking water.

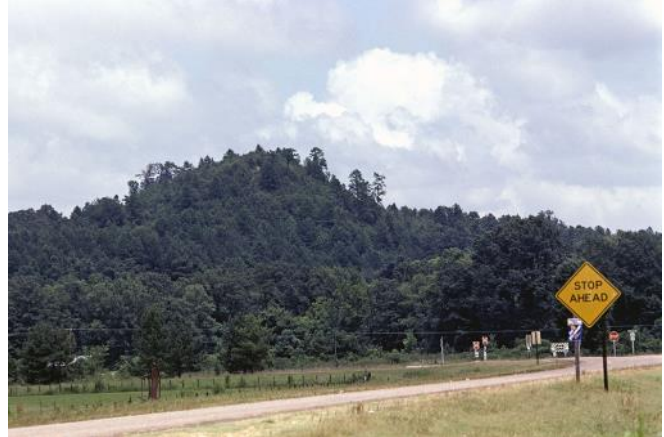
Figure 14. Duck Hill on Highway 51 in Montgomery County. The hill is an outlier of the Kociusko Formation. Picture (Kodachrome slide 13-8; Image 507) taken in August of 1975.

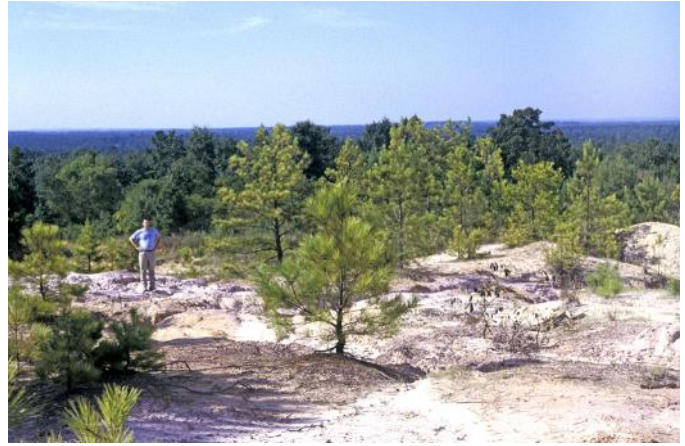
Figure 17. View from terrace deposit at 580 feet west of Cone Hill Church in the NW/4, NW/4, Section 33, T. 5 N., R. 4 E., Rankin County, Mississippi. Terrace sands below contain pebbles composed of Tripoli and no chert pebbles. Picture (slide 384-14; Image 26) taken on September 14, 2004.

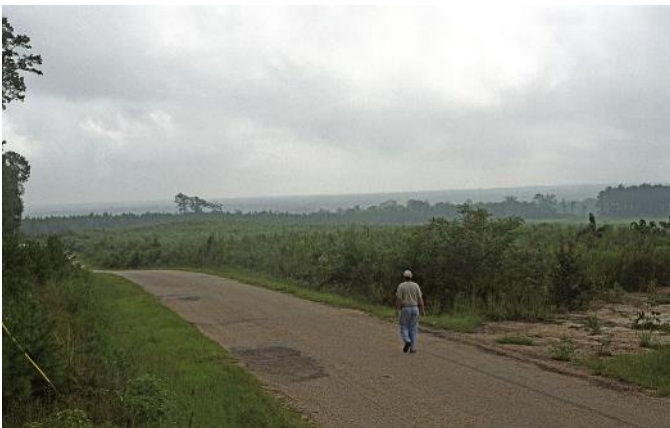
Figure 18. James Starnes on road at the surface crest of the Ruth Salt Dome at an elevation of 570 feet above sea level with a view to the east of ridge-forming Citronelle terraces. Picture (color negative 592-2; Image 649) taken on September 11, 2006.

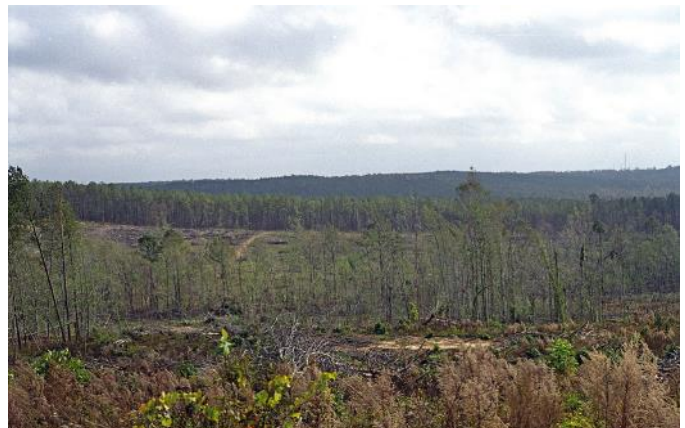
Figure 19. View of Citronelle-capped hills near Turkey Ridge in north-central Jasper County where the Citronelle Formation onlaps the Yazoo Clay. Picture (color negative 560-16; Image 354) taken on November 15, 2005, looking east from a hunting camp dirt road in the SW/4, NE/4, Section 8, T. 3 N., R. 12 E. Ridge in the distance reaches an elevation of 570 feet above sea level.

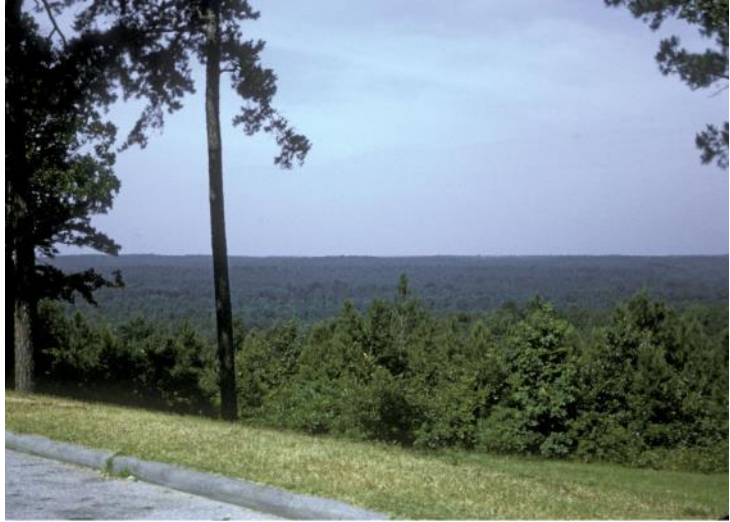
Figure 28. View to the northeast from the Wilcox Cuesta at Little Mountain in Jeff Busby Park on the Natchez Trace Parkway in the upper reaches of the Big Black River Basin. Picture was taken in July of 1973.

er divide northward to that point. Little Mountain (**Figure 28**) is an outlier of the high ground of the Wilcox Cuesta at the triple basin junction of the Big Black, Pearl, and Tombigbee river basins. The low elevations of the Tombigbee River Basin are on the soils of the Black Belt (**Figure 27**), soils that develop from easily weathered chalks and marls in the Selma Group. **Figure 29** is a LiDAR bare earth hillshade relief image showing rugged terrain along the western margin of the Tombigbee River Basin and at the triple basin junction with the Pearl and Big Black river basins. In the east, the Tombigbee River Basin is characterized by low prairie land; in the west, the upper Pearl and Big Black river basins are characterized by higher elevations and greater relief. This varied terrain correlates with the varied bedrock geology beneath it.

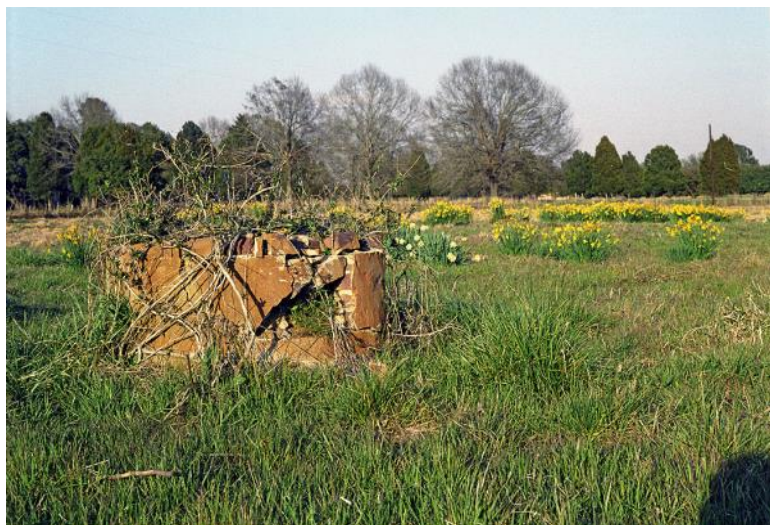
Figure 35. How to find an abandoned cistern in late winter time? Look for the flowers around the old home site. The cistern and flowers are now in a large field on the Jackson Prairie along Kickapoo Road in northwestern Hinds County, where the Yazoo Clay was too thick to permit hand dug wells. Picture (color negative 569-2: Image 341) taken on March 5, 2006.

Even if Dinsmoor had dug his well twice as deep, it would still have been dry, because the Yazoo Clay is as much as 400 feet thick in the Ridgeland area. The Agency later dug an additional cistern to supplement their water supply. Today cisterns of old home sites dot the landscape of the Jackson Prairie across central Mississippi where the Yazoo Clay is thick (**Figure 35**). Similar cisterns dot the landscape of the Black Prairie and Flatwoods in northeastern Mississippi on the Cretaceous chalk and Porters Creek clay belts. Crider

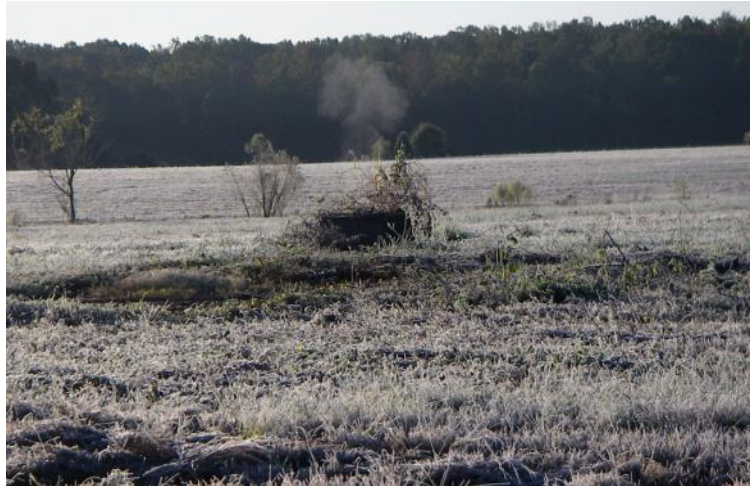
Figure 36. How to find an abandoned cistern on a cold fall morning? Look for a puff of vapor rising from an old home-site. This is the same cistern as in the previous figure. It is in a field on the south side of Kickapoo Road on the Yazoo Clay outcrop belt in northwest Hinds County. Picture (digital; Image 1107) was taken on the morning after the first fall frost on October 28, 2008.

Cisterns have been used since ancient times in areas where ground-water resources were very deep or absent. They generally have a narrow neck at the surface and expand below to a large cylinder or basin to catch the rainwater funneled from the roof of a house. A cistern on the north side of Kickapoo Road near the intersection of Tinnin Road in northwestern Hinds County is typical of many cisterns on the Yazoo Clay outcrop belt. It has a modest brick, well-like upper structure and concrete covering at the surface, which hides a huge cavity below--a deep and expanded cylindrical cavity that looks like a missile silo. This structure was built large enough to store rainwater from wet months to be used in the dry months or, even worse, in dry years. Before drinking the water, it was best to sieve out the "wiggly worms" through a cloth. Even so, the coliform bacterial count from bird droppings and other sources would not pass our Health Department standards of today. On cold winter mornings, abandoned cisterns can be spotted along Kickapoo Road along the sides of rolling fields or by cedar groves by the ascension of their wispy vapors, the only records of long forgotten homesteads (**Figure 36**).

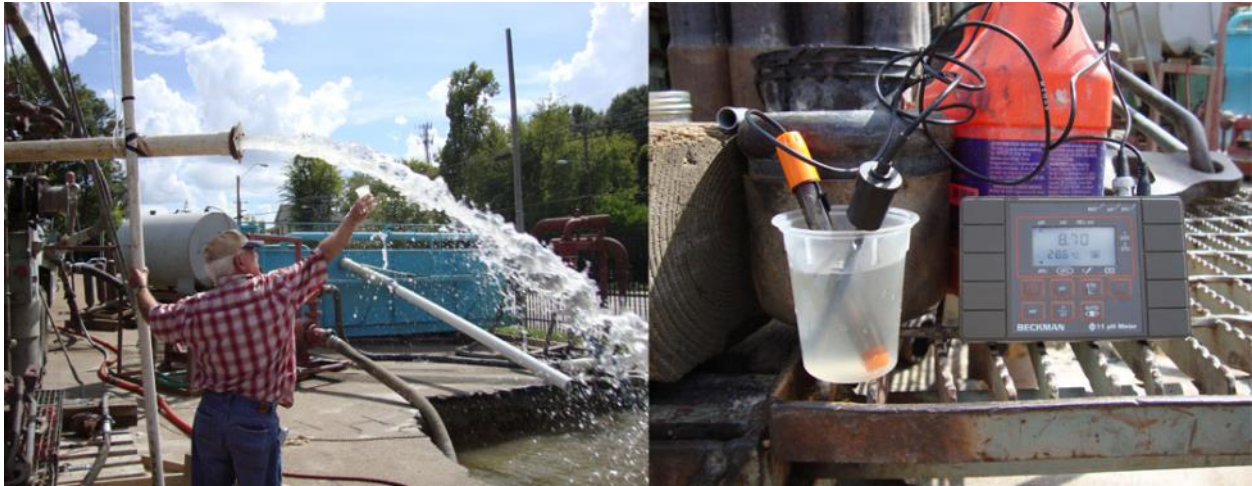
Figure 49. Bill Oakley collecting a water sample during the 200-gallon-per-minute pumping test on the Baptist Hospital #1 water well (left); and the water-well temperature and pH measurements (right). Pictures (digital composite; Image 1630) taken on September 7, 2010.

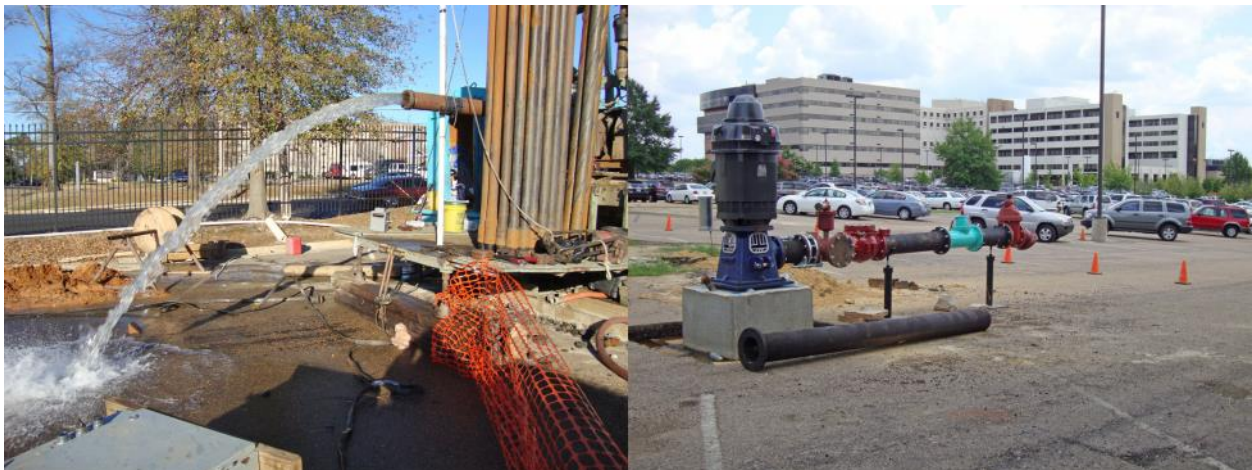
Figure 50. Left, 700-gallon-per-minute pump test of the second Baptist Hospital test well as was taken on January 28, 2011. Right, the Baptist Hospital #2 water well completed with pump and pipes at the well head as was taken on July 14, 2011. Composite Image 1927.

Figure 50 is a composite image that shows (at left) the pump test for the second Baptist Hospital well, which drilled into a thick basal channel sand in the Sparta Formation. At right, the figure shows the completed well head with pump and pipe fittings. The 24-hour test was run at a rate of 700-gallons-per-minute. This well has a recommended pumping rate of 1,000 to 1,200 gallons a minute. An example of a channel-sand deposit is given in **Figure 51**, which shows a channel sand in the middle Tuscahoma Formation exposed at the Red Hills Lignite Mine in Choctaw County, Mississippi. The channel sand cuts out lignite seams in the lower Tuscahoma Formation and rests on the underlying Nanafalia Formation. Ground water in the middle Tuscahoma channel has caused slope instability and has been a problem at the mine site.

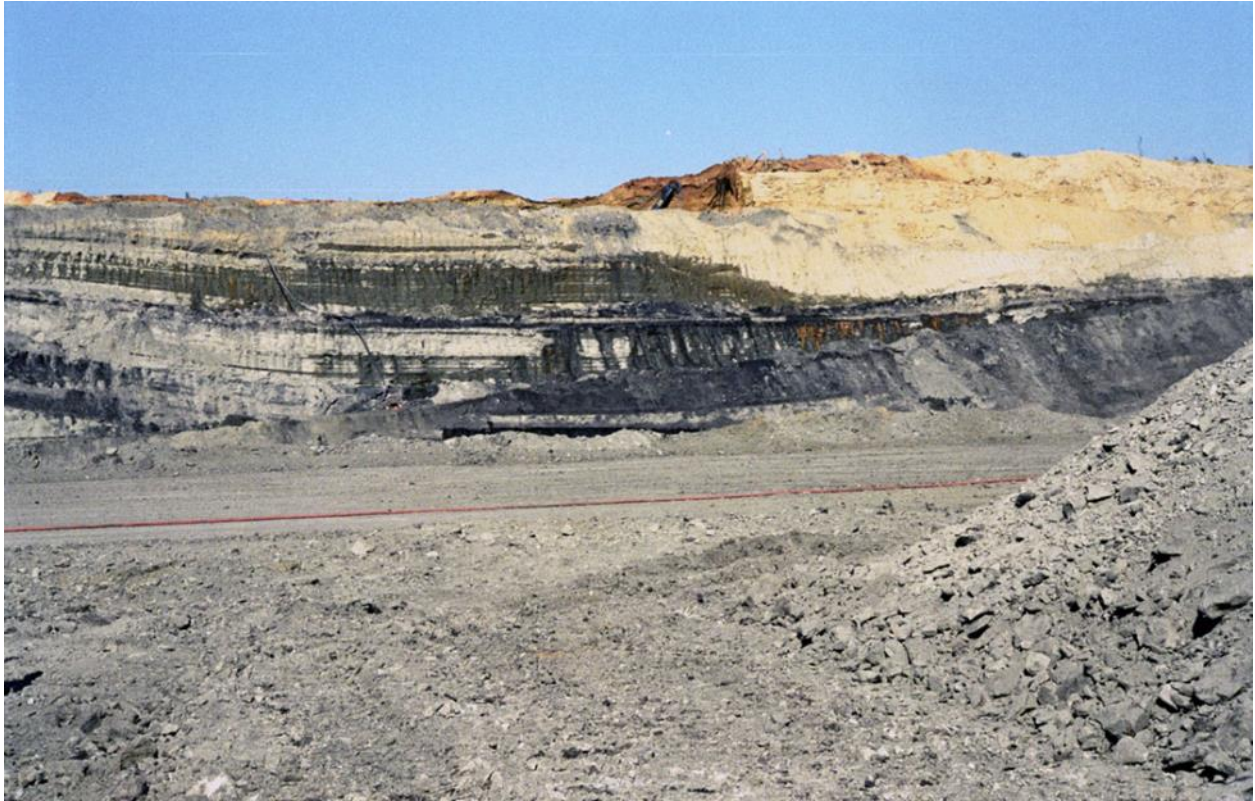
Figure 51. Lignite seams bend beneath a fluvial channel sand (upper right) in the middle Tuscahoma Formation, which cuts out the I and H2 lignites seams of the lower Tuscahoma. The red cable carries 60,000 volts to power the dragline. Picture (color negative 531-16; Image 325) taken on November 11, 2004.

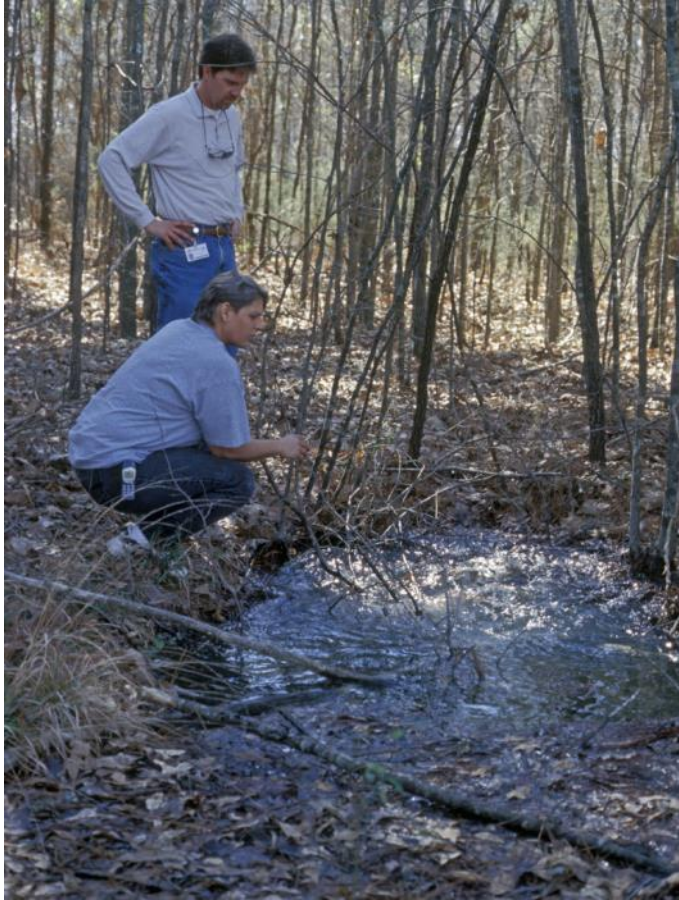
Figure 53. Meg Myers and Ken McCarley inspecting a supposed spring with 82 degree F water on a hilltop in Rankin County. The “spring” proved to be a broken 2-inch water line. Picture (slide 348-7) was taken on February 13, 2002.

these cities had warm water running though their water mains. Though well water is pumped into water tanks exposed to cold air, it doesn’t stay there long enough to cool down much. One example of this was a supposed spring I (and others) inspected in Rankin County on a cold day on February 13, 2002. The problems with this spring were that it was on a hilltop rather than at the base of a hill, and the water was warm (**Figure 53**). We were told that the spring had been there some 20 years; it had carved a significant ravine down the hill side. Spring water in central Mississippi has a temperature of about 65 degrees F, the ambient temperature of shallow aquifers in the region. The “spring” water we measured with a laboratory-grade mercury thermometer was 82 degrees F. When we reported this to Wilbur Baughman, a water-well contractor who once worked for the Mississippi Geological Survey and wrote the Rankin County Geology Bulletin, he said “That’s Sparta water,” Sparta being the name of a deep aquifer. We notified the Greenfield Water Association of our findings; they later found the “spring” to be a break in one of their 2-inch pipes.

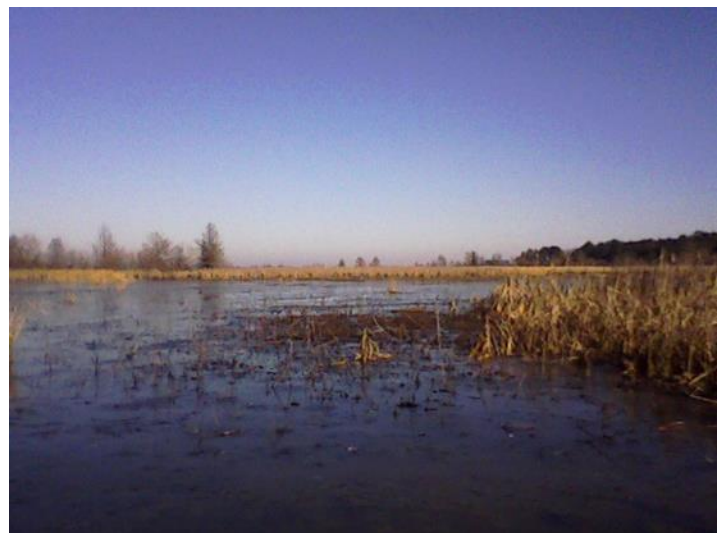
Figure 54. Cell phone picture taken by a duck hunter of frozen water at Pine Islands on the Rankin County side of the Ross Barnett Reservoir. Picture taken by James Starnes at about 8:00 a.m. on Tuesday, January 12, 2010, after state employees were sent home on Monday at noon.

The Ross Barnett Reservoir was partially frozen over (**Figure 54**) during a 67-hour

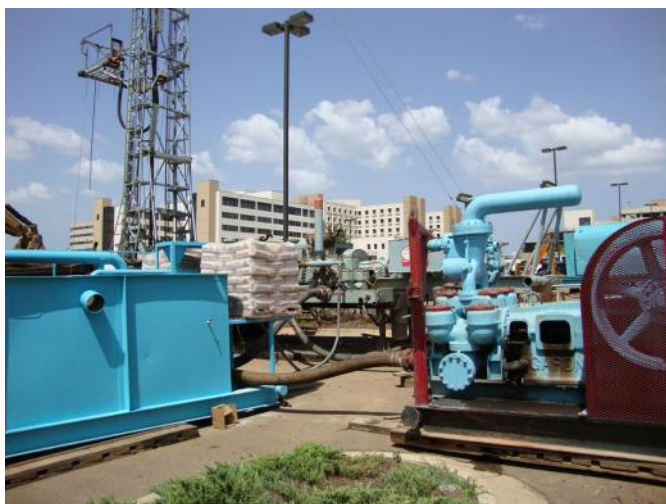
Figure 57. Drilling of an eight-hundred-foot-deep well in the Sparta aquifer by Donald Smith Company for the Baptist Hospital. Picture (digital; Image 1551) was taken on June 22, 2010.

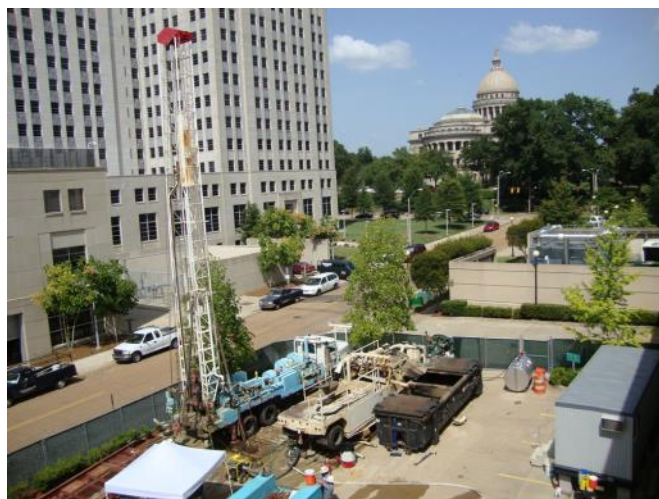
Figure 58. Drilling of the N-158 well, an eight-hundred-foot-deep well in the Sparta aquifer by the Donald Smith Company. Picture (digital; Image 1552) was taken on July 22, 2010.

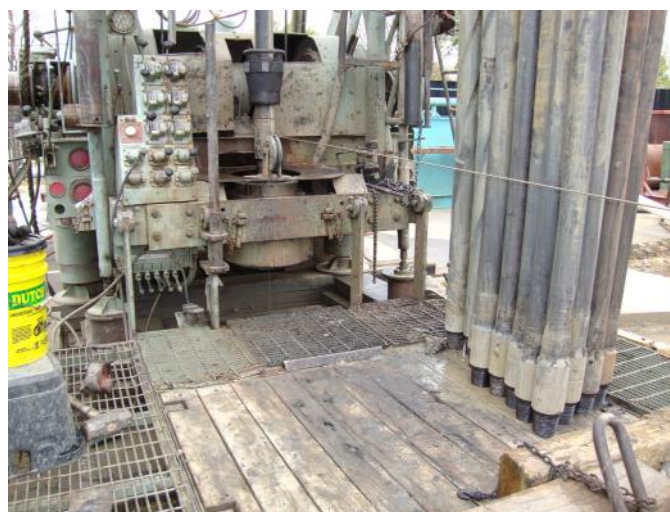
Figure 65. Logging cable extending from the drill hole and breakout table of the drilling rig to the logging van operated by the Mississippi Office of Geology. The drill hole is a test hole for the Baptist Hospital #3 water well in Jackson, Mississippi. Picture (digital; Image 1933) was taken on March 30, 2011.

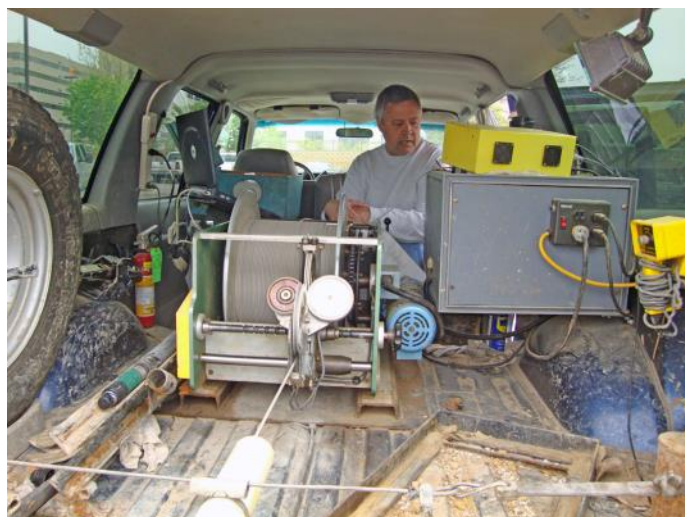
Figure 66. John Marble monitors the digital logging unit, while logging the Baptist Hospital #3 well. In front of him is the cable drum, and to his right is the display screen showing the geophysical log. Picture (digital; Image 1934) was taken on March 30, 2011.

Today the Office of Geology uses modern technology with Mount Sopris digital logging units. **Figures 66-67** shows the logging of the Baptist Hospital #3 well in Jackson, Mississippi. Over the years the Office of Ge-

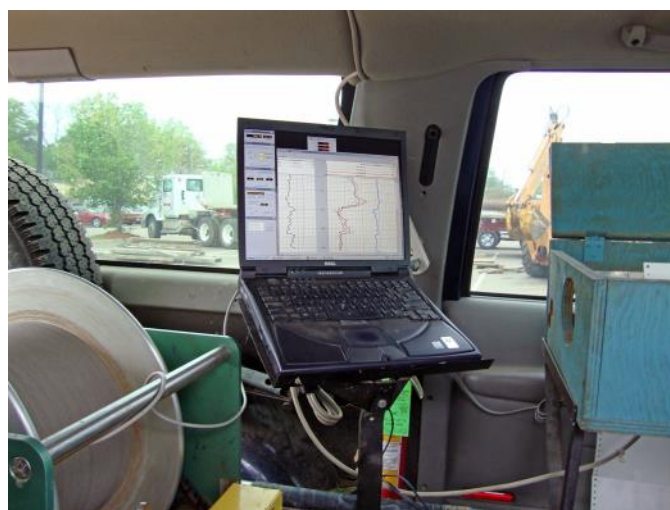
Figure 67. Computer display screen showing a portion of the Baptist Hospital #3 geophysical log as well logging is underway. Picture (digital; Image 1935) was taken on March 30, 2011.

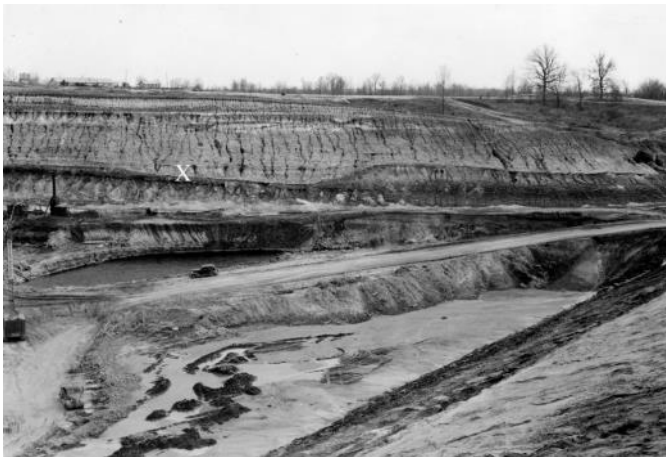
Figure 69. Unconformable contact (X) of Kosciusko sand overlying Zilpha clay in the distant construction cut for Sardis Lake. Picture (scan of print, DVD 57; Image 1015) dated March 21, 1940.

and (4) Grenada Lake on the Yalobusha River completed in 1954. **Figure 69** shows the construction of Sardis Lake and the unconformable contact of the Zilpha Clay and Kosciusko Formation. **Figures 70 and 71** show the topping of the Sardis emergency spillway by floodwaters associated with the Mississippi River flood of 1973.

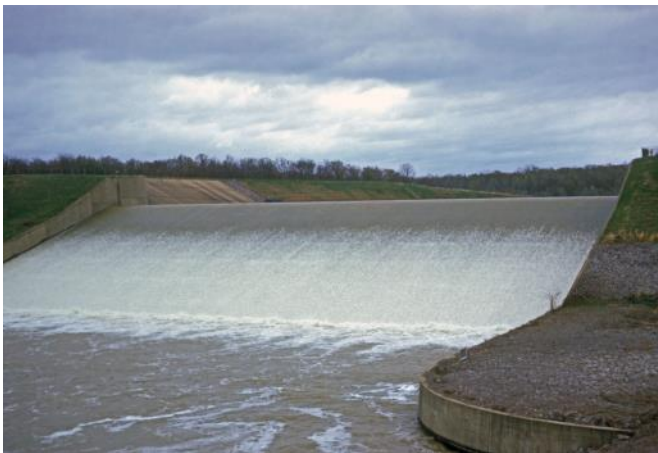
Figure 70. Sardis Lake tops its emergency spillway for the first time in the flood of March 1973. Picture (slide; Image 1787) was taken in March of 1973.

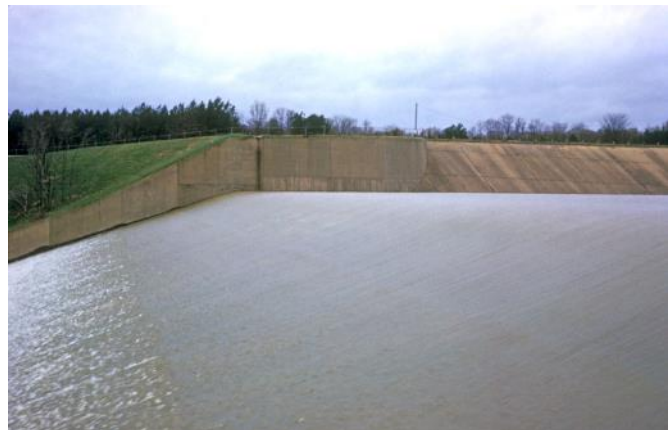
Figure 71. Overflow of the emergency spillway at Sardis Lake during the flood of March 1973. Picture (slide; Image 1788) was taken in March of 1973.

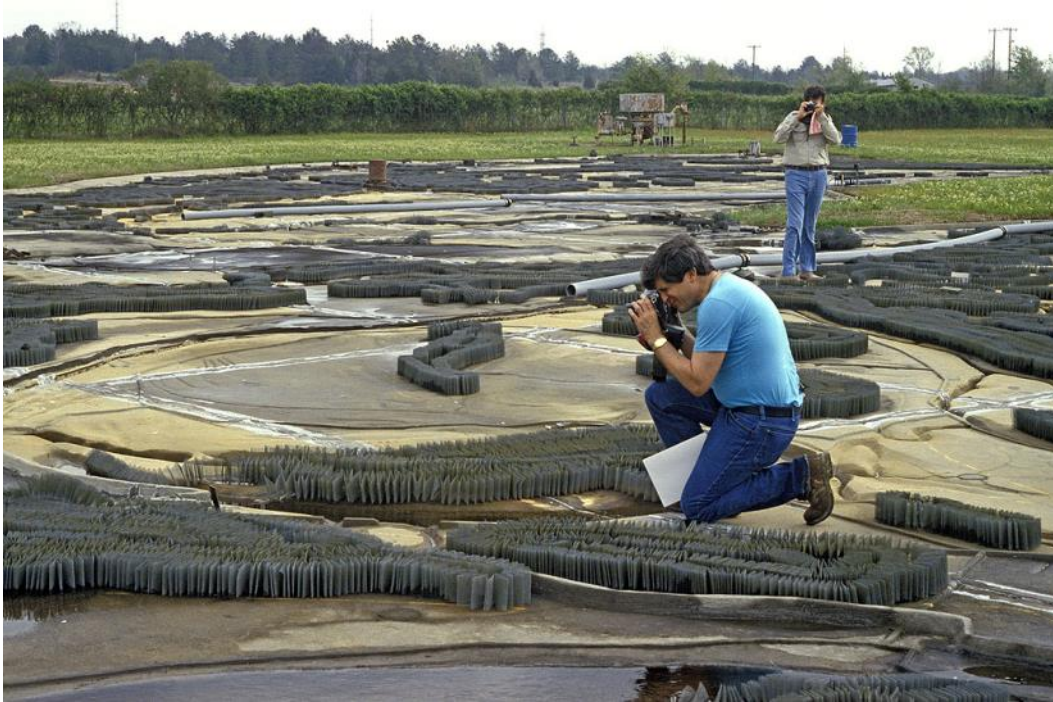
Figure 72. John Armentrout (front) photographing the Mississippi River hydraulic model at Clinton, Mississippi, the largest physical hydraulic model of its time. Picture (slide 153-4; Image 521) was taken on March 28, 1985.

In the 1940s, German prisoners of war were used to build a scale model of the Mississippi River at Clinton, Mississippi, to predict flood crests based on the water flow entering the Mississippi River Basin. This model was used in the flood of 1973, when it proved to better predict flood crest than the computer model used at that time (**Figures 72 and 73**). **Figure 74** shows the major historic flood crests depicted on the flood wall at Vicksburg, Mississippi. **Figure 75** shows the water mark (bathtub ring) left by the 2009 flood.

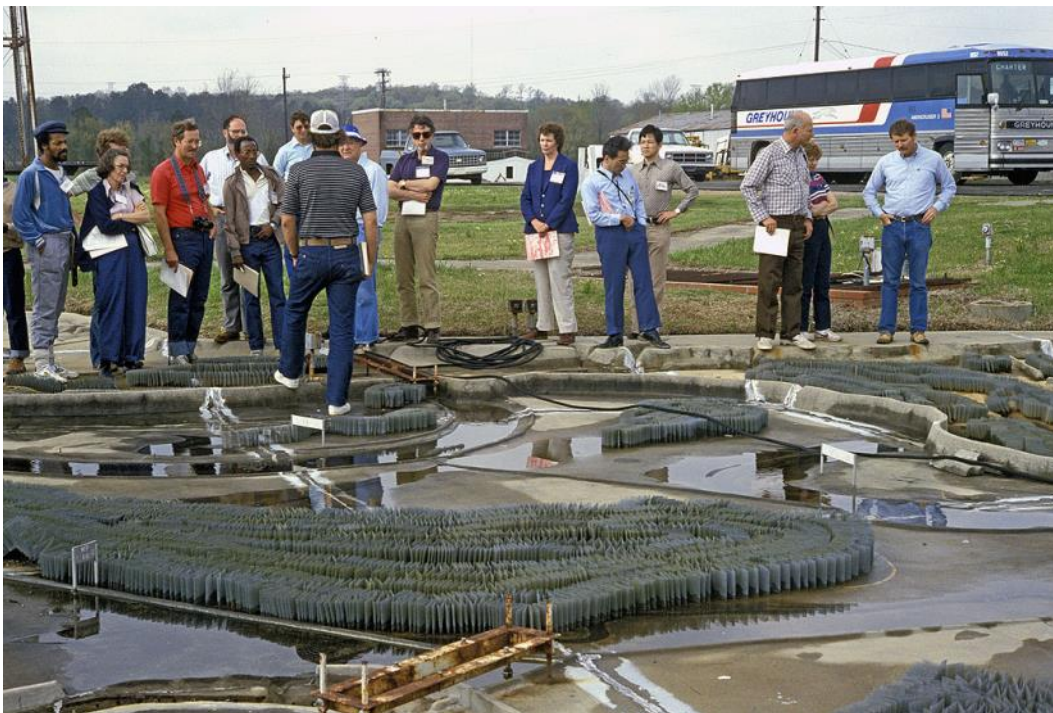
Figure 73. Mississippi River hydraulic model at Clinton, Mississippi; built by German prisoners of war in the 1940s, it was last used to accurately predict flood crests during the 1973 Mississippi River flood when computer models were found to be inadequate. It has been allowed to deteriorate since this picture was taken. Picture (slide 153-5; Image 522) was taken on March 28, 1985, during an AAPG field trip.

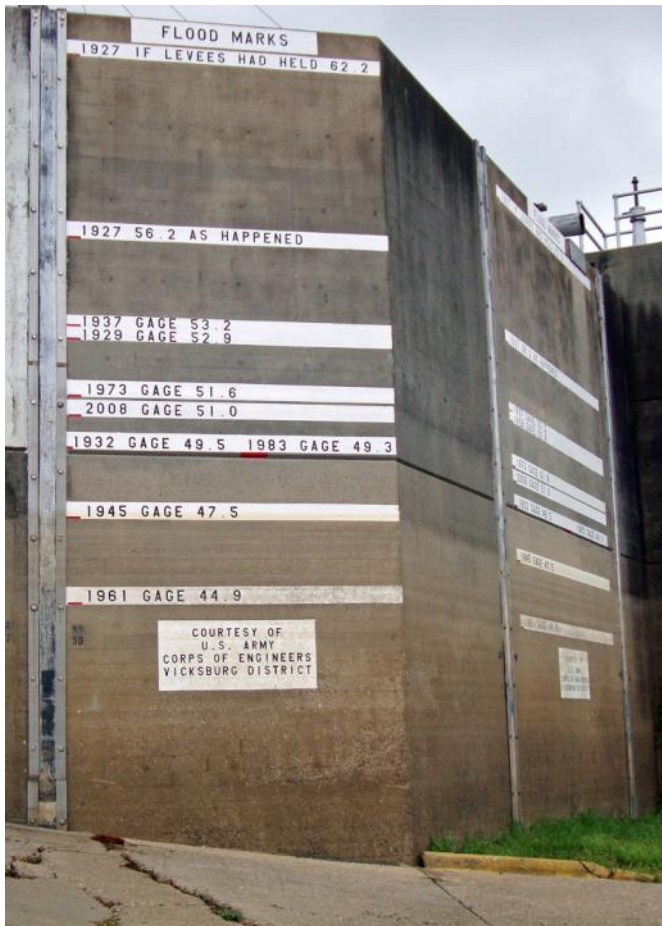
Figure 74. Vicksburg flood wall with historical flood crests marked by the U.S. Army Corps of Engineers. The water lines (bathtub rings) for the 2008 and 2009 floods can be seen to the right of the facing wall. Picture (digital; Image 1801) was taken on September 26, 2009.

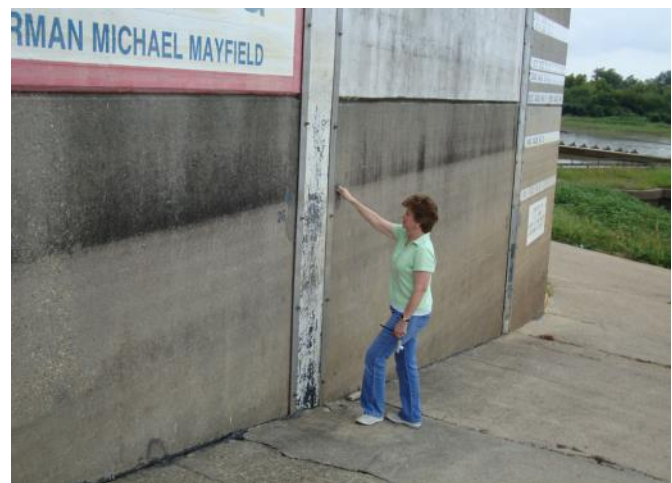
Figure 75. Ida Marshall pointing to the “bathtub ring” above the flood crest of the 2009 Mississippi River flood on the Vicksburg flood wall. Picture (digital; Image 1802) was taken on September 26, 2009.

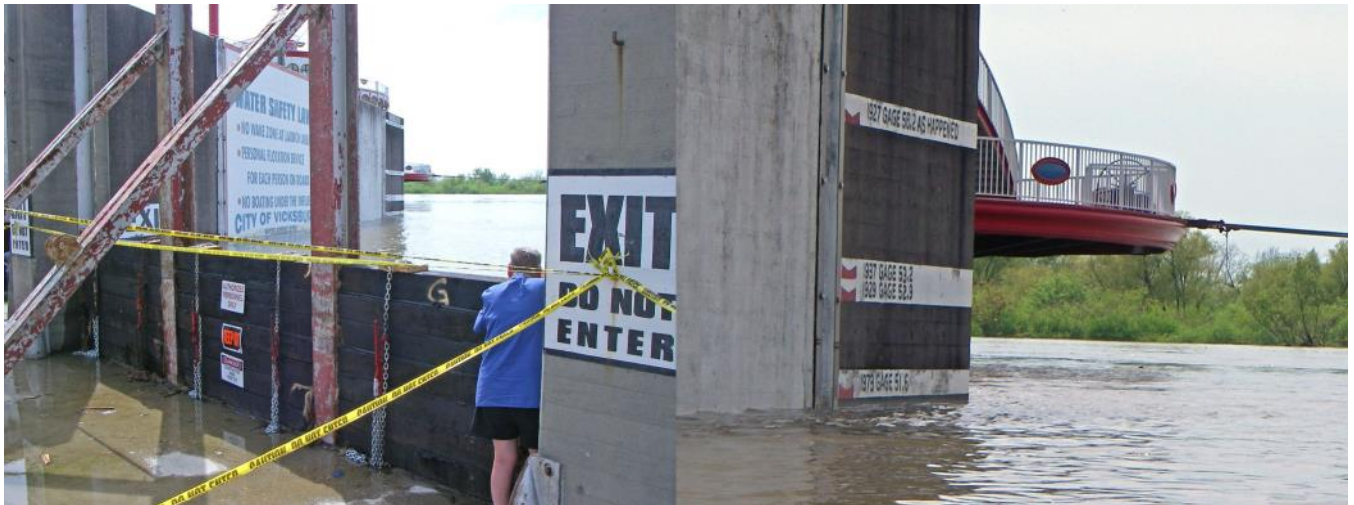
Figure 76. The 2008 Mississippi River flood crest as seen at the Vicksburg flood gate and on the flood wall, just below the 1973 level. Pictures (digital; Images 1790 and 1791) were taken on April 20, 2008.

-foot flood crest of 1973, some 35 years earlier. The U.S. Army Corps of Engineers placed the 2008 crest level on the Vicksburg flood wall with those of other historic crests (**Figure 76**). **Figure 77** shows the water mark of the 2009 flood crest on the floodwall at Vicksburg.

Figure 76 shows the planked up flood gate in 2008, and a photograph of the crest against the flood wall as taken from the flood gate. The flood of 2009 did not require the closure of the flood gate, but, as seen on the flood wall, it rose to the level of an historic flood in 1945 (**Figure 77**). In both the 2008 and 2009 floods, Highway 465 was closed just west of Highway 61 due to flooding, which turned the farmland of the lower Yazoo River

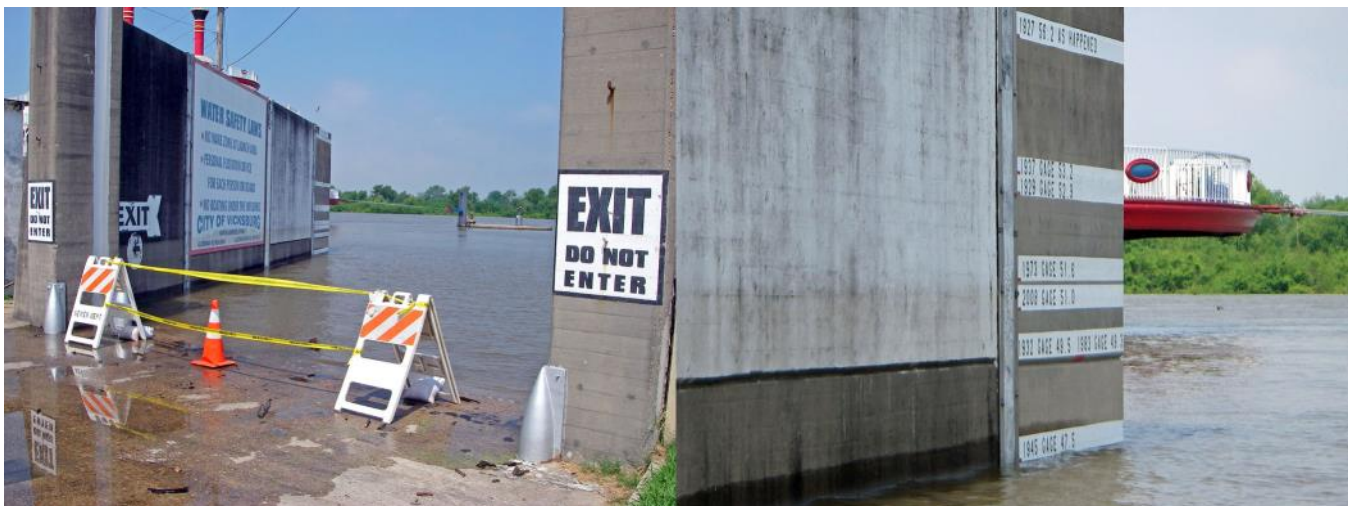
Figure 77. Vicksburg flood gate (left) and flood wall (right) at the crest of the 2009 flood, which rose to the level of the 1945 flood crest. Pictures (digital; Images 1795 and 1796) were taken on May 26, 2009.

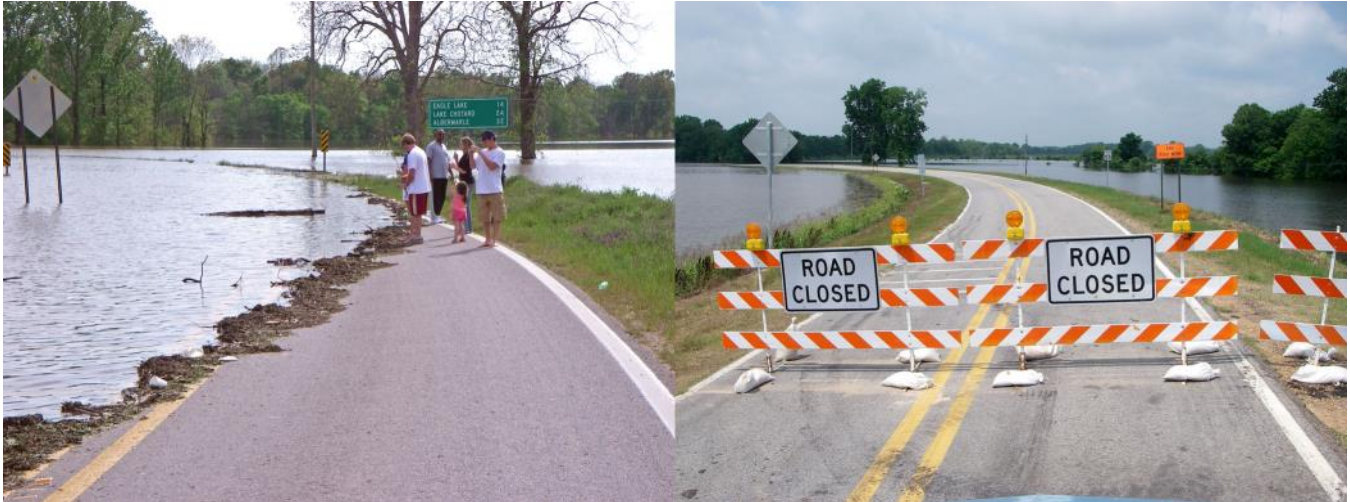
Figure 78. Highway 465 just west of Highway 61 during the 2008 (left) and 2009 (right) flood crests. Picture on left (digital; Images 1792) was taken on April 20, 2008; picture on right (digital; Image 1797) was taken on May 26, 2009.

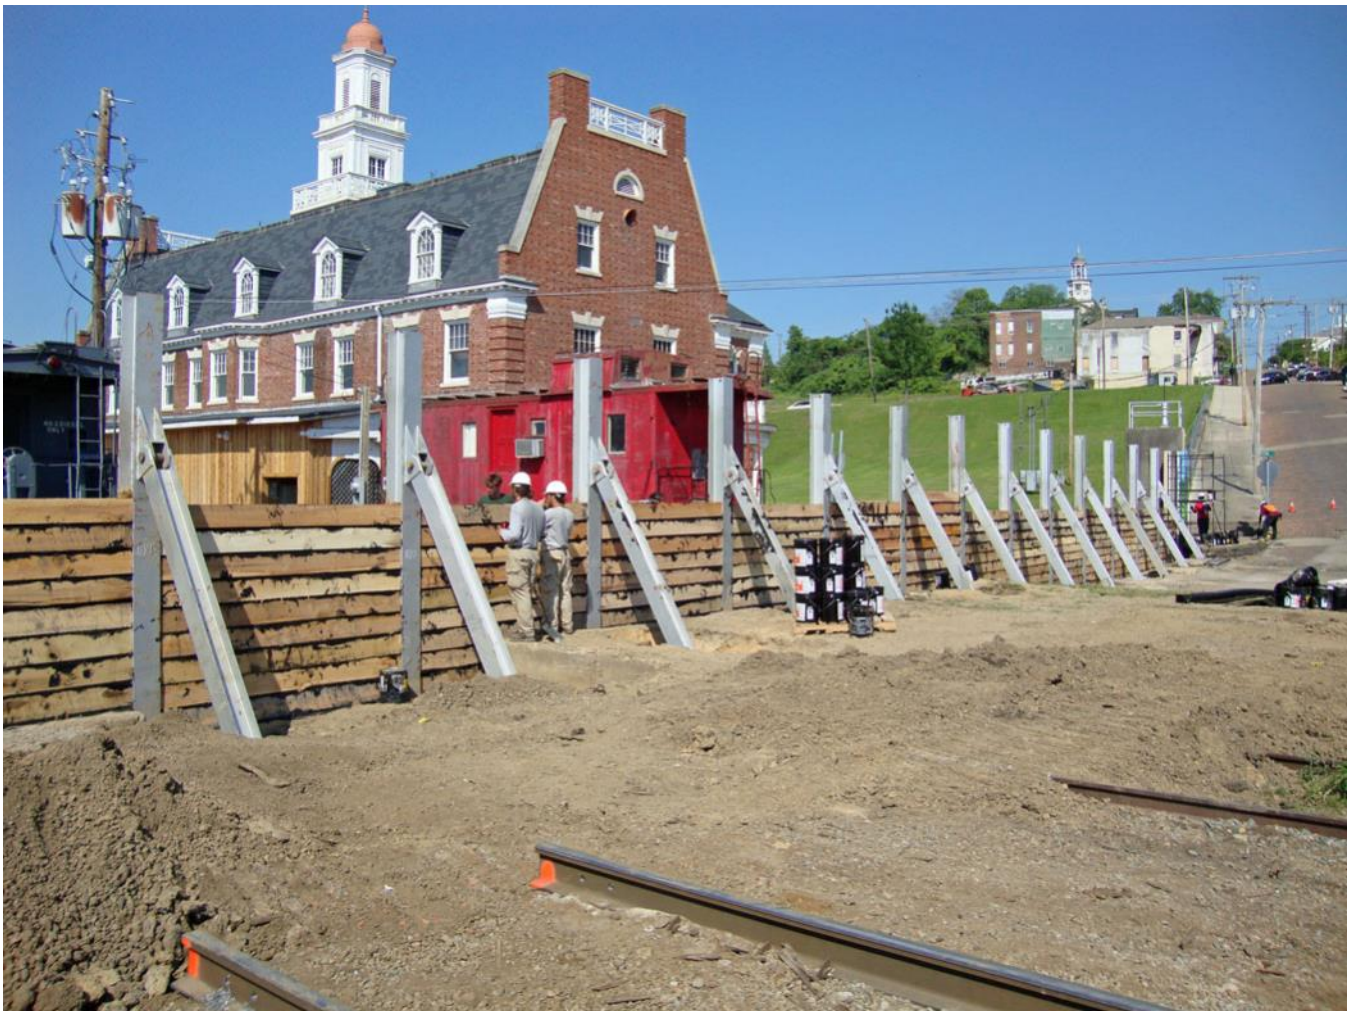
Figure 79. Planking up and tarring the north end of the Vicksburg flood wall. Picture (digital; Image 1879) was taken on May 6, 2011.

The flood gates at Vicksburg were planked all the way to the top in preparation for the Great Flood of 2011. This planked closure had to be extended along the north end of the flood wall (**Figure 79**). Photographing the rising crest on the flood wall in 2011 (**figures 80-81**) required a 24-foot extension ladder and Homeland Security clearance from Vicksburg Emergency Management Director Anna Booth and notification of Lieutenant Davey Barnett of the Vicksburg Police Department. The Great Flood of 2011 not only covered Highway 465 (**Figure 82**) but also sections of Highway 61 (**Figure 83**) and many homes and businesses (**Figure 84**). With a crest of 57.1 feet

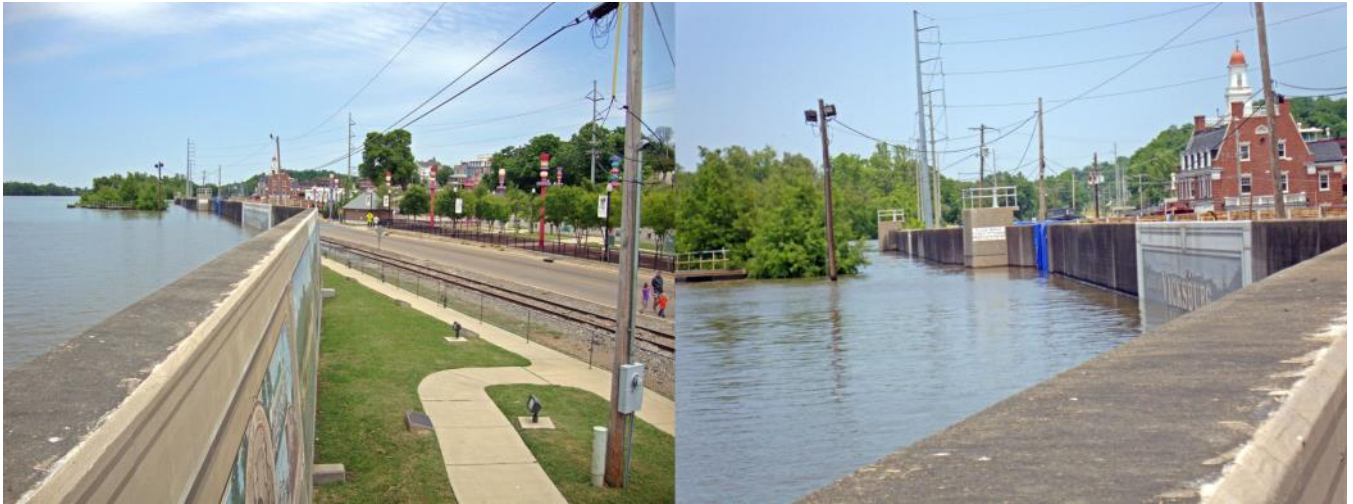
Figure 81. The Mississippi River flood crest of 2011 on the flood wall at Vicksburg. Picture (digital; Composite image 1873) was taken on May 9, 2011.

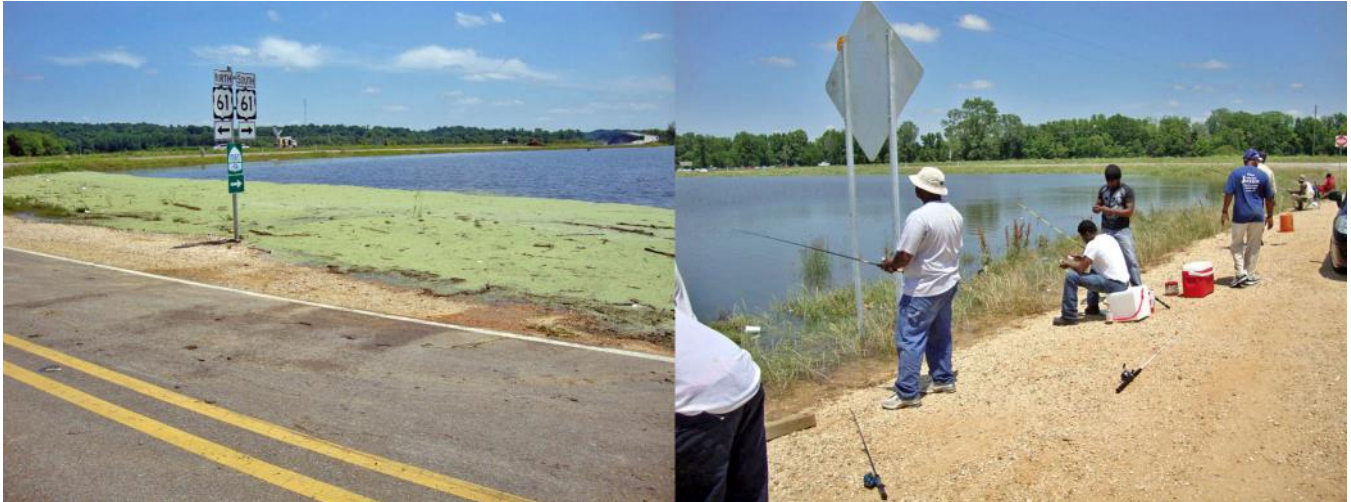
Figure 82. 2011 flood waters have submerged all but a small peninsula of Highway 465 and threaten to cover Highway 61. Pictures (digital; Composite image 1874) were taken on May 11, 2011.
